PLANNING COMMISSION AGENDA
City Commission Chambers - City Hall
625 Center Street, Oregon City, Oregon 97045
June 13, 2011 at 7:00 p.m.

Oregon City - Historic Review Program - Historic Survey & Update Project

Oregon City Historic Review Program Historic Survey & Update Project

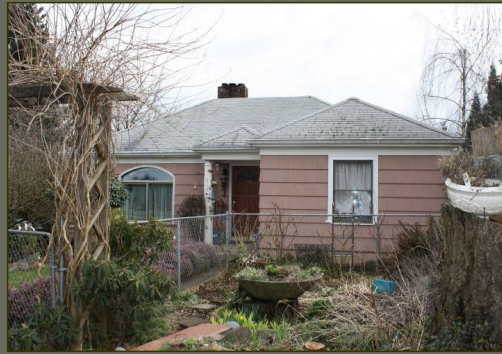
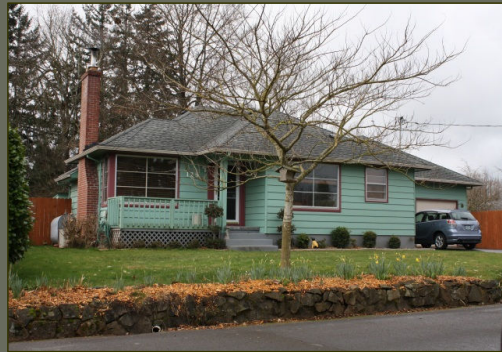
World War II-era Cottage

Character-defining features

- Shallow-sloped hip roof; no eaves
- Recessed or side entry door
- Double-hung &/or corner windows with horizontal lights
- Decorative round or octagonal focal windows

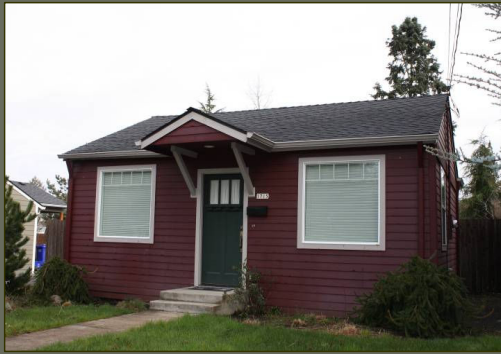
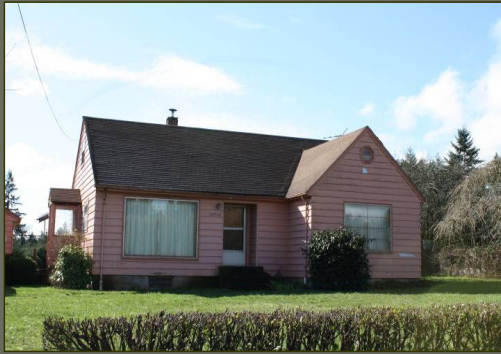
Minimal Traditional House

Character-defining features

- Side gable or hip roof; narrow or no eaves
- Square or slightly rectangular plan
- Small covered stoop
- Varied materials
- Double-hung windows & small picture window

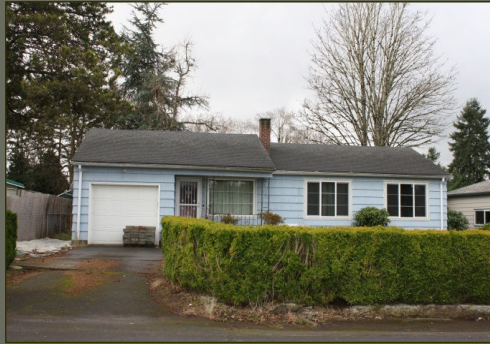
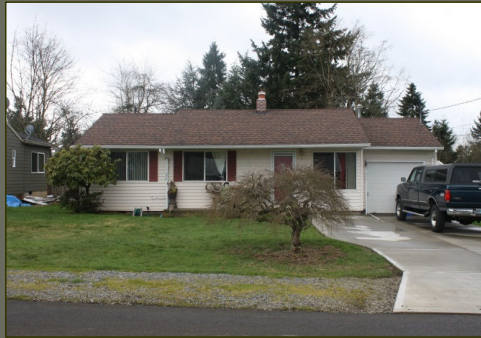
Early Ranch House

Character-defining features

- Side gable or hip roof
- Slightly rectangular footprint
- Open floor plan
- Horizontal-oriented windows
- Integral one-car garage

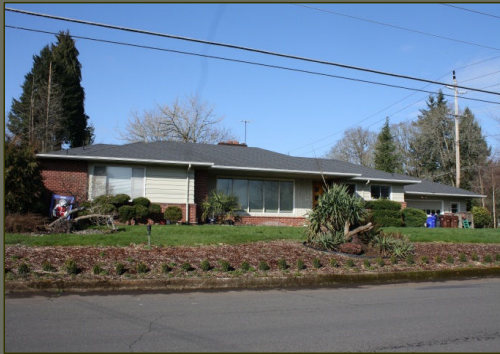
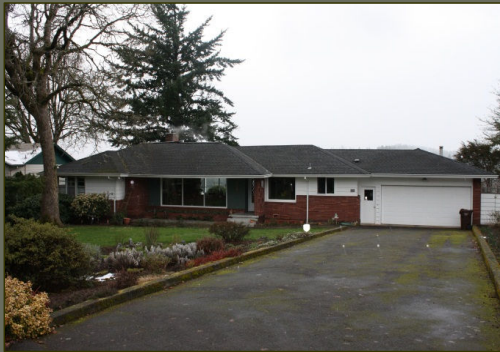
Ranch House

Character-defining features

- Shallow-sloped gable or hip roof; deep overhangs
- Long rectangular footprint; horizontal aspect
- Horizontally-oriented windows
- Horizontally-oriented cladding such as wide boards and Roman brick

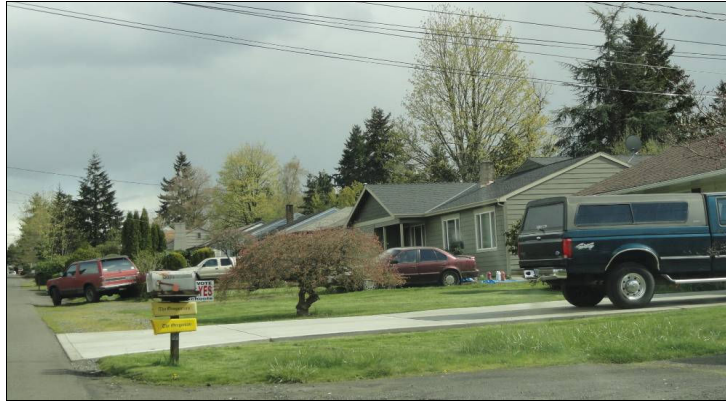
Figure 12 – Rivercrest's smaller lots became popular directly after World War II

Newer homes were built south of Park Drive and further from the park. As shown below, these homes are more modest and built on smaller lots, yet still show many of the hallmarks of mid-century development. The rolled curbs are absent, but these lots are also facing wide streets without sidewalks and with generous setbacks.

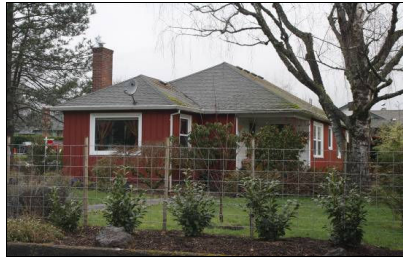
***World War II-era Styles:
The World War II-era Cottage***

The World War II-era cottage is a compact building with a nearly square floor plan reflecting the Basic or Minimal house plan type.

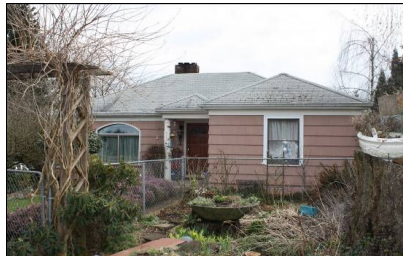
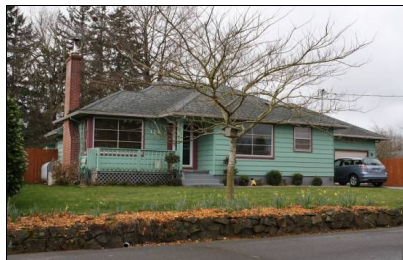
A World War II-era cottage often has a shallow-sloped hip roof, no eaves, and a recessed entry. It can display a variety of window types, but steel casement or double-hung wood-frame windows with horizontally-oriented lights are often seen. Window type is one of the most unique features of many World War II era cottages. These homes may be found with wrapped corner windows on the primary façade, with round or octagonal windows near the entry, and with large square focal windows. Large chimneys are also common.

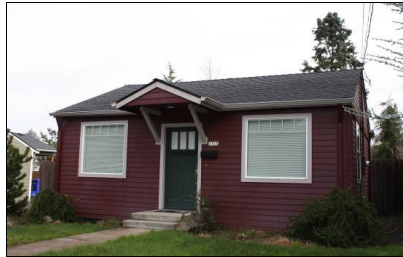
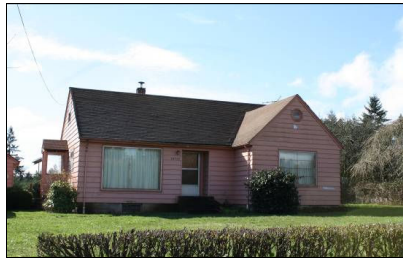
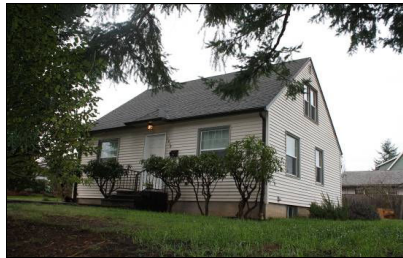
***World War II-era Styles:
The Minimal Traditional House***

The Basic or Minimal house refers to a plan type that came out of studies sponsored by the Federal Housing Administration (FHA) and controlled through the FHA regulations of the 1930s. It refers to a plan type(s) that minimizes circulation space and maximizes multi-use spaces, such as kitchen-dining or dining-living spaces in the interest of economic efficiency.

Typical characteristics of the Minimal Traditional house include a gable or hip roof, narrow or non-existent eaves, a square or slightly rectangular plan, and ‘traditional’ windows such as paired or single double-hung windows with multiple lights and shutters, although this era also saw emergence of the picture window.

Visual interest is often provided by cladding materials, such as clapboard with brick accents or shingle siding. Minimal Traditional homes were generally built without porches but often include small concrete stoops covered by gables, as seen in the Oregon City examples to the left. Minimal traditional houses are generally one story in height.

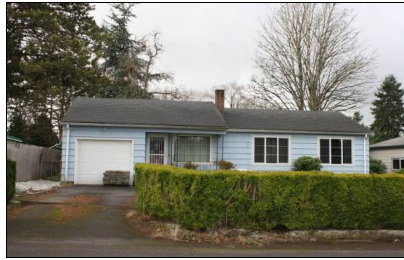
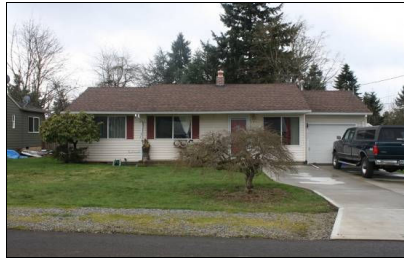
***Post World War II Styles:
The Early Ranch House***

The Ranch house was popular throughout the United States and assumed many forms and style variations, although the most common Ranch houses in Oregon City are the Early Ranch and the well-known Ranch style house. The Early Ranch house has a simple rectangular footprint and does not display the variations seen in the later Ranch house.

The Ranch house has an open floor plan in the public areas, where the dining and living rooms or kitchen and dining rooms may be combined. The kitchen is typically a small galley kitchen, often with a “pass-through” to the dining area. Bedrooms are often aligned along a hallway, rather than centered on a small vestibule, as in World War II-era houses. This was the era in which the family room made an appearance as well. The single car garage or a carport was typically integrated with the house, but could be separated from it by a breezeway.

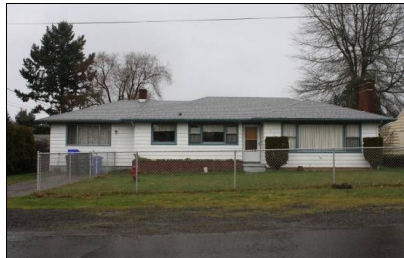
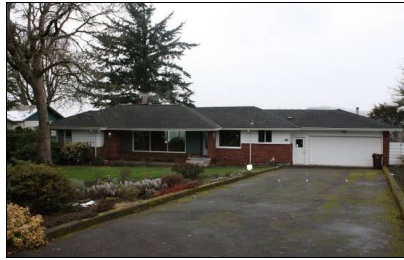
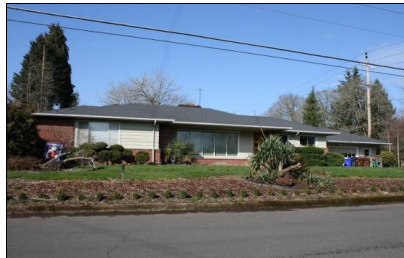
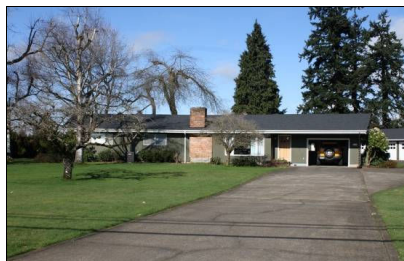
Post World War II Styles: The Ranch House

The origins of the Ranch house lie in its rustic, southern California and American southwest roots. But the Ranch house of post-war America could take many forms. Form types include L-shaped houses, U-shaped houses, houses arranged around a courtyard, split-level houses, which are one- and two-stories, and split-entry houses, which are two stories. There are Traditional Ranch houses, which display rustic details, and Contemporary Ranch houses, which have clean, modern lines. Character Ranch houses take on the architectural details of other styles, such as Colonial Revival. The long, low rambling Ranch is often referred to as a Rambler. All share a long, low profile and an overall horizontal aspect.

The primary feature that distinguishes the Ranch house from World War II-era home is its horizontal aspect. After cars replaced streetcars as the primary mode of transportation, developers were able to move further from the city center, where land was cheap and easy to develop. Small city lots with compact houses were replaced by larger homes with wide facades that extended from side lot line to side lot line. The back yard was thus preserved for privacy and family recreation.

Characteristics of a Traditional Ranch include a long, narrow, open porch, a reference to the corridor of the traditional hacienda, and rustic finishes including variegated brick and board-and-batten, and wood shingle roofs. Oregon City Ranch houses tend to be relatively straight forward in design, but variations are seen, including a few Contemporary Ranch houses. Split-level and split-entry Ranch houses are common in Oregon City, but most were built in the 1960s beyond the time frame for this survey.

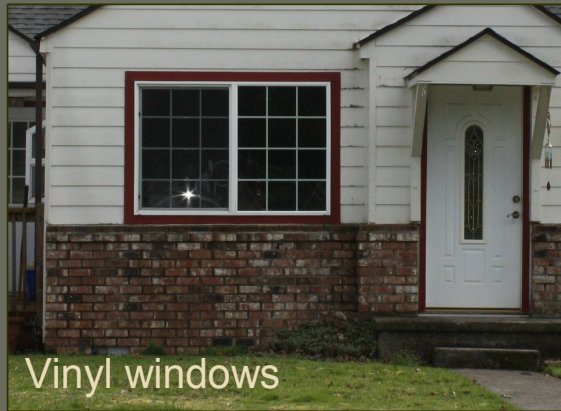
Issue 1 – Replacement windows

Vinyl windows

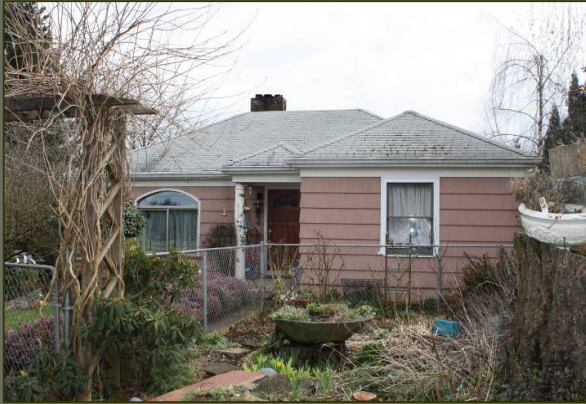
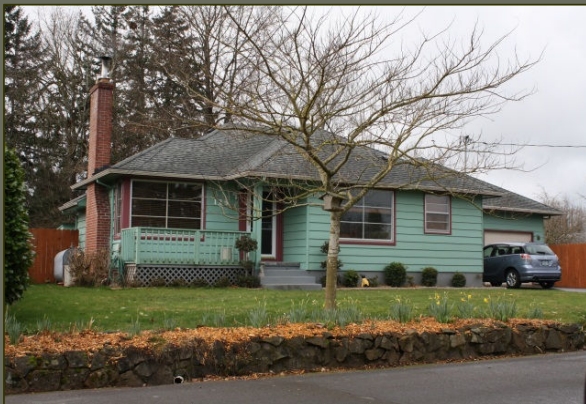
World War II-era Cottage

- Shallow-sloped hip roof; no eaves
- Recessed or side entry door
- Double-hung &/or corner windows with horizontal lights
- Decorative round or octagonal focal windows

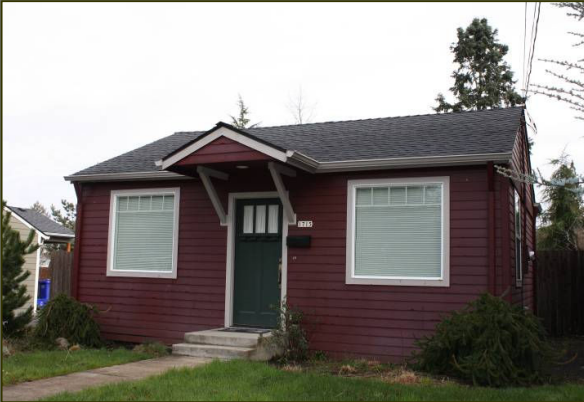
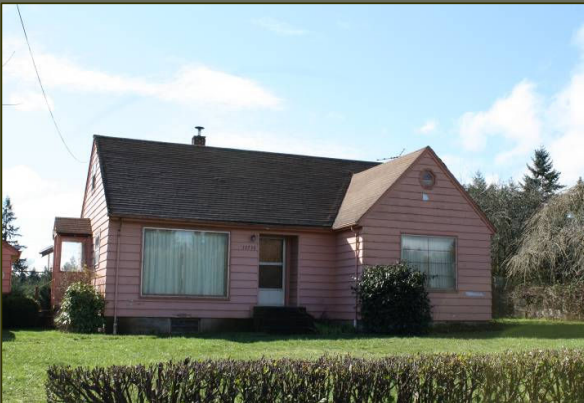
Minimal Traditional House

- Side gable or hip roof; narrow or no eaves
- Square or slightly rectangular plan
- Small covered stoop
- Varied materials
- Double-hung windows & small picture window

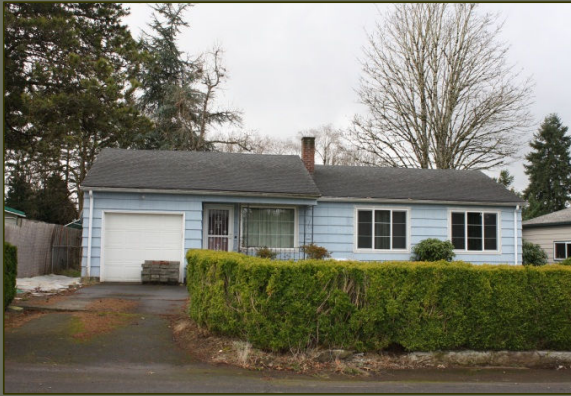
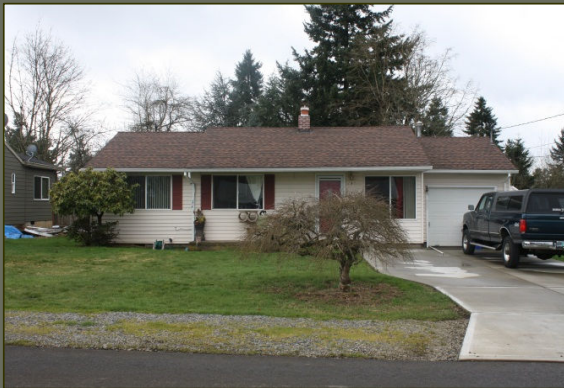
Early Ranch House

- Side gable or hip roof
- Slightly rectangular footprint
- Open floor plan
- Horizontal-oriented windows
- Integral one-car garage

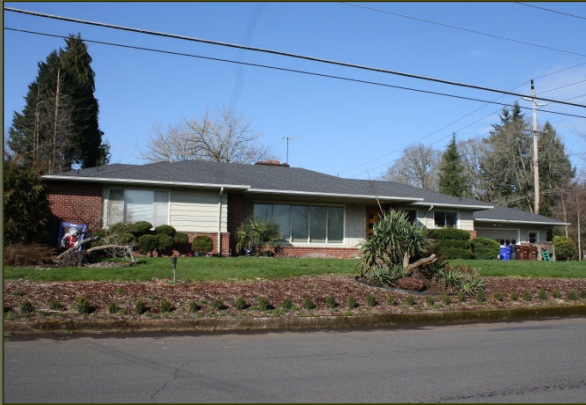
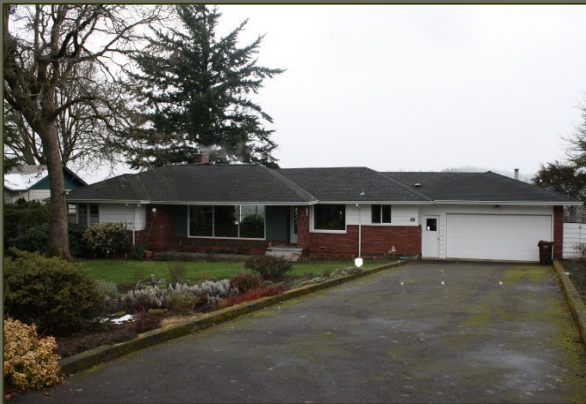
Ranch House

- Shallow-sloped gable or hip roof; deep overhangs
- Long rectangular footprint; horizontal aspect
- Horizontally-oriented windows
- Horizontally-oriented cladding such as wide boards and Roman brick

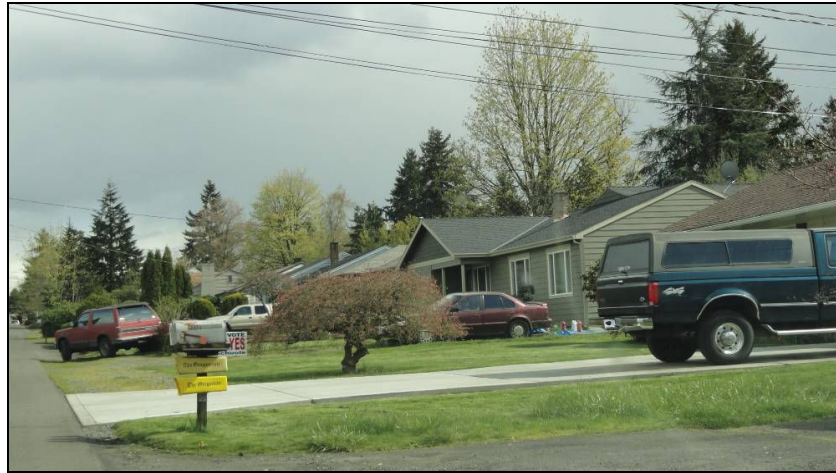
Figure 12 – Rivercrest's smaller lots became popular directly after World War II

Newer homes were built south of Park Drive and further from the park. As shown below, these homes are more modest and built on smaller lots, yet still show many of the hallmarks of mid-century development. The rolled curbs are absent, but these lots are also facing wide streets without sidewalks and with generous setbacks.

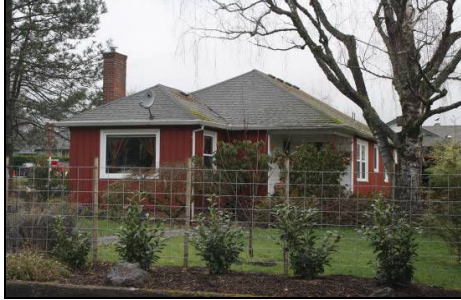
***World War II-era Styles:
The World War II-era Cottage***

The World War II-era cottage is a compact building with a nearly square floor plan reflecting the Basic or Minimal house plan type.

A World War II-era cottage often has a shallow-sloped hip roof, no eaves, and a recessed entry. It can display a variety of window types, but steel casement or double-hung wood-frame windows with horizontally-oriented lights are often seen. Window type is one of the most unique features of many World War II era cottages. These homes may be found with wrapped corner windows on the primary façade, with round or octagonal windows near the entry, and with large square focal windows. Large chimneys are also common.

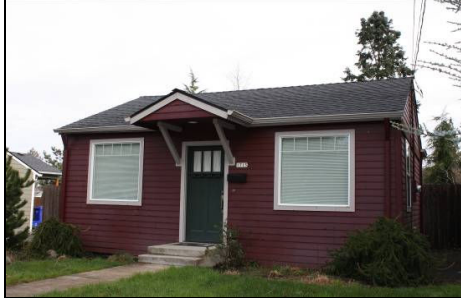
***World War II-era Styles:
The Minimal Traditional House***

The Basic or Minimal house refers to a plan type that came out of studies sponsored by the Federal Housing Administration (FHA) and controlled through the FHA regulations of the 1930s. It refers to a plan type(s) that minimizes circulation space and maximizes multi-use spaces, such as kitchen-dining or dining-living spaces in the interest of economic efficiency.

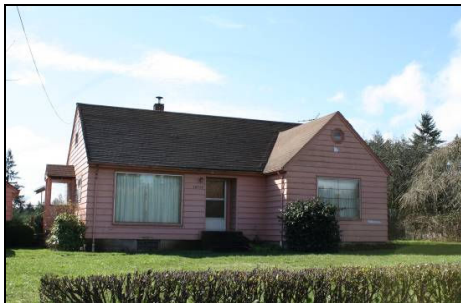
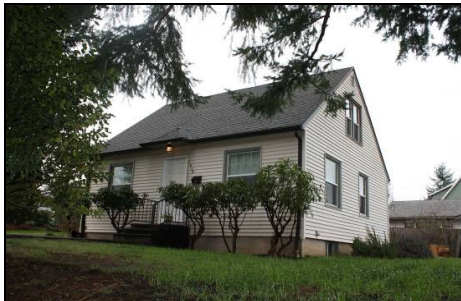
Typical characteristics of the Minimal Traditional house include a gable or hip roof, narrow or non-existent eaves, a square or slightly rectangular plan, and ‘traditional’ windows such as paired or single double-hung windows with multiple lights and shutters, although this era also saw emergence of the picture window.

Visual interest is often provided by cladding materials, such as clapboard with brick accents or shingle siding. Minimal Traditional homes were generally built without porches but often include small concrete stoops covered by gables, as seen in the Oregon City examples to the left. Minimal traditional houses are generally one story in height.

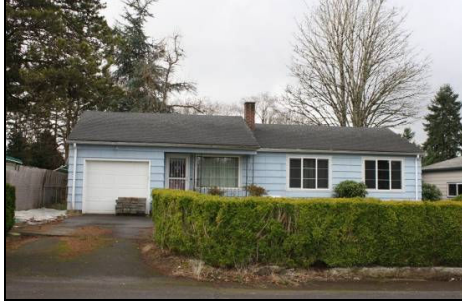
***Post World War II Styles:
The Early Ranch House***

The Ranch house was popular throughout the United States and assumed many forms and style variations, although the most common Ranch houses in Oregon City are the Early Ranch and the well-known Ranch style house. The Early Ranch house has a simple rectangular footprint and does not display the variations seen in the later Ranch house.

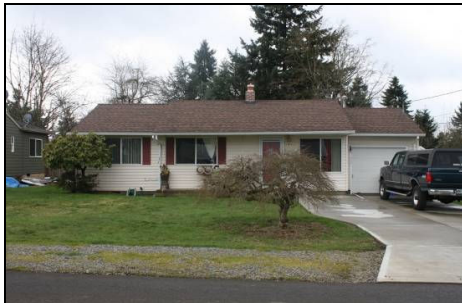
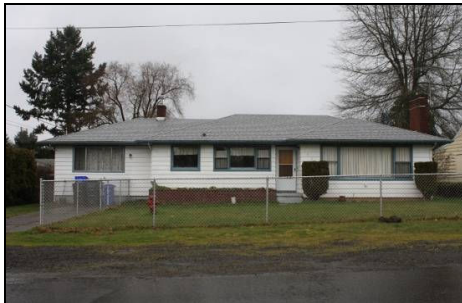
The Ranch house has an open floor plan in the public areas, where the dining and living rooms or kitchen and dining rooms may be combined. The kitchen is typically a small galley kitchen, often with a “pass-through” to the dining area. Bedrooms are often aligned along a hallway, rather than centered on a small vestibule, as in World War II-era houses. This was the era in which the family room made an appearance as well. The single car garage or a carport was typically integrated with the house, but could be separated from it by a breezeway.

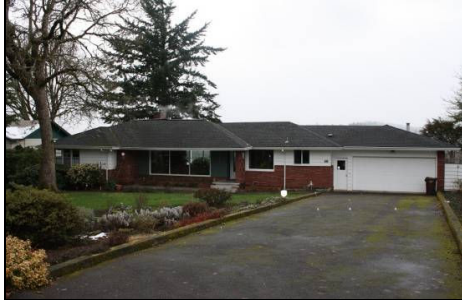
***Post World War II Styles:
The Ranch House***

The origins of the Ranch house lie in its rustic, southern California and American southwest roots. But the Ranch house of post-war America could take many forms. Form types include L-shaped houses, U-shaped houses, houses arranged around a courtyard, split-level houses, which are one-and-two-stories, and split-entry houses, which are two stories. There are Traditional Ranch houses, which display rustic details, and Contemporary Ranch houses, which have clean, modern lines. Character Ranch houses take on the architectural details of other styles, such as Colonial Revival. The long, low rambling Ranch is often referred to as a Rambler. All share a long, low profile and an overall horizontal aspect.

Characteristics of a Traditional Ranch include a long, narrow, open porch, a reference to the corridor of the traditional hacienda, and rustic finishes including variegated brick and board-and-batten, and wood shingle roofs. Oregon City Ranch houses tend to be relatively straight forward in design, but variations are seen, including a few Contemporary Ranch houses. Split-level and split-entry Ranch houses are common in Oregon City, but most were built in the 1960s beyond the time frame for this survey.

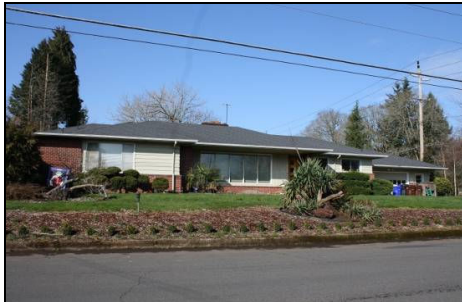
Character Defining Features

The primary feature that distinguishes the Ranch house from World War II-era home is its horizontal aspect. After cars replaced streetcars as the primary mode of transportation, developers were able to move further from the city center, where land was cheap and easy to develop. Small city lots with compact houses were replaced by larger homes with wide facades that extended from side lot line to side lot line. The back yard was thus preserved for privacy and family recreation.

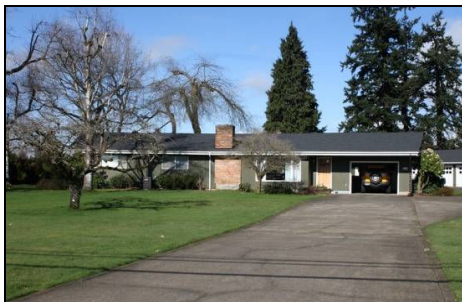
The resulting Ranch house is generally one story with projecting eaves that give them a “ground-hugging” appearance. Strong horizontal lines are further emphasized by shallow-pitched, side gable and hip roofs with deep overhangs, horizontal board cladding, and horizontally-oriented windows, often with narrow Roman brick cladding underneath.
